# PRÜFTECHNIK *success story*

> Application **Cardan Shaft Alignment**

## Mine saves two workdays during time-critical shutdown

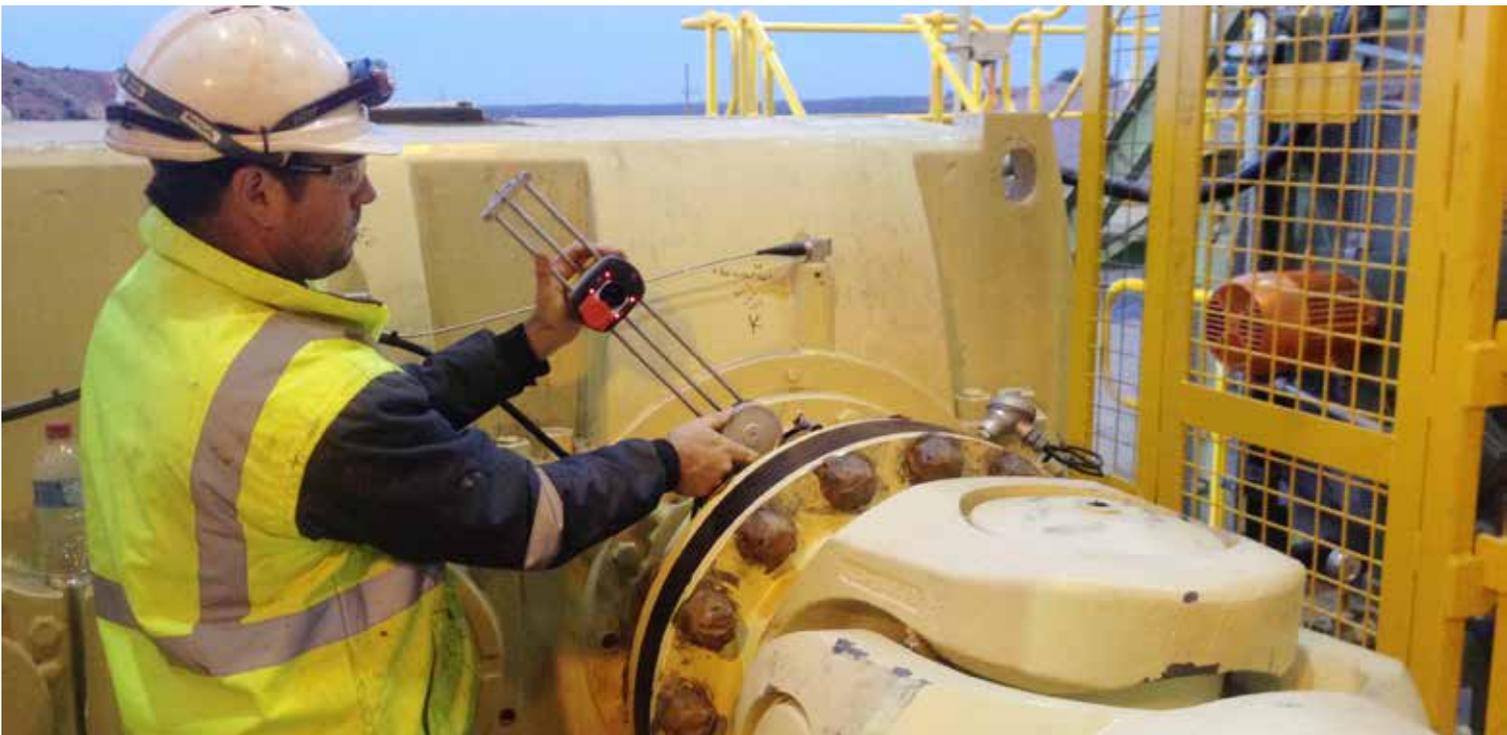
In September 2013, the company needed to perform the alignment of a three-machine train with two cardan shafts at a gold mine in Western Australia. The machine train consisted of an arrangement of conveyor pulley, gearbox and motor.

One of the cardan shafts weighed over 7500 kg with a shaft length of around 4 meters. Originally, the plan was to perform the alignment uncoupled, as this was the only option. Typically, the removal of the shaft would have taken a full day, and the whole alignment process up to two days, involving a team of 4-5 people and considerable labour and crane hire costs. Not to mention the safety risks and possible machine damage during removal and replacement of the shaft.

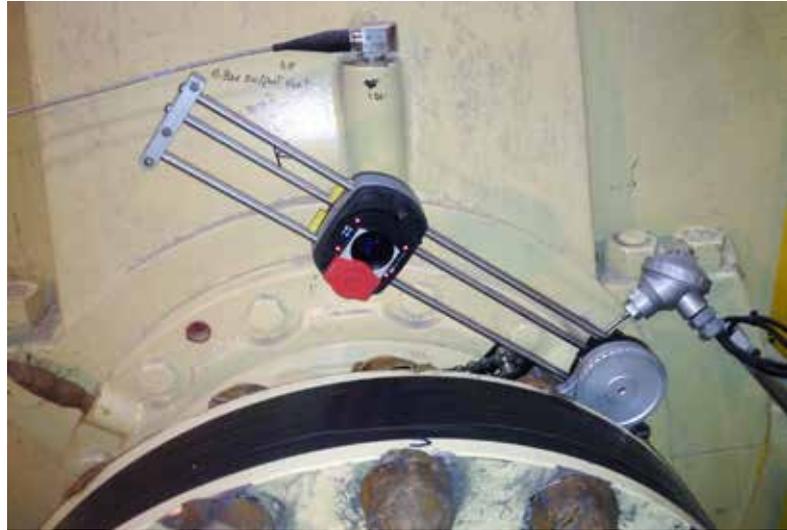
The laser was set up at the stationary end using a non-rotating arm bracket. At the moveable machine end of the shaft, a rotating arm bracket was used to mount the sensor. As the coupled shaft was rotated to each new measurement position, the rotating arm bracket was turned back at the base and the sensor moved along the posts to intersect the laser beam and take the necessary readings. The procedure was repeated at several shaft angular positions to capture the alignment condition, after which the required machine adjustments were made and checked.

**The entire measurement task was completed without removal of the 7500 kg cardan shaft.**
