PRUFTECHNIK Service Center

Reducing Cardan Errors for Low-Vibration Operation of Coupled Machines

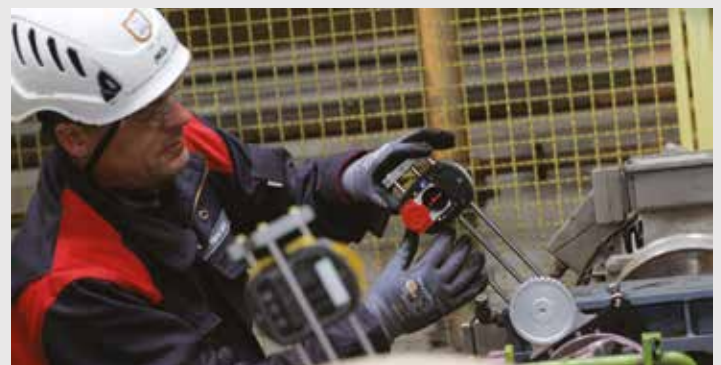
Laser-optical alignment of an installed cardan shaft

However, achieving perfect compensation is difficult in reality and requires competent laser-optical alignment of cardan shafts in the removed as well as installed state.
